# TEST REPORT

SUBJECT N°/REPORT: P-13-15346/3/1

TESTED MATERIAL: One plastic material

It was requested to perform an accelerated aging test according to UL1581, and mechanical properties evaluation before and after aging according to UNE EN ISO 527-2.

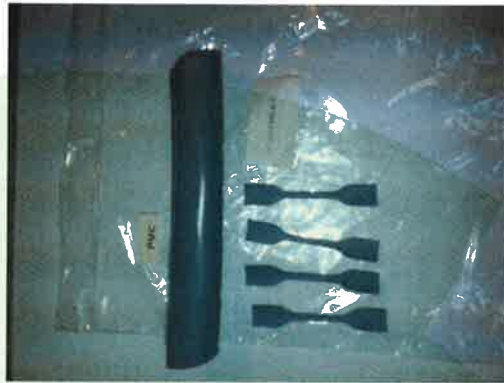
P-13-15346-A-1

Specimens of a plastic material were received from **BTC IBÉRICA, S.A.** for an accelerated aging test and the evaluation of mechanical properties before and after accelerated aging.

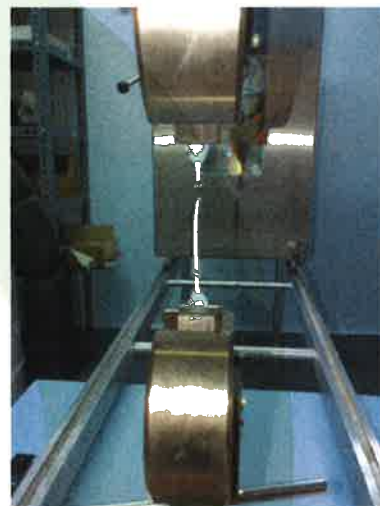
Tensile test

- Tensile strength and modulus of elasticity according to UNE EN ISO 527-2:2012

Test	Average
Tensile strength (MPa) Before aging	19,9
Elongation (%) Before aging	260
Tensile strength (MPa) After aging	19,1
Elongation (%) After aging	250
